APOLLO RCS POSITIVE EXPULSION TANKAGE
PRODUCT IMPROVEMENT PROGRAM
FINAL REPORT - TASK E

SOLUTION OF COMMAND MODULE
AND SERVICE MODULE
BLADDER REPOSITIONING PROBLEMS

Bell Report No. 8514-928006
19 March 1970

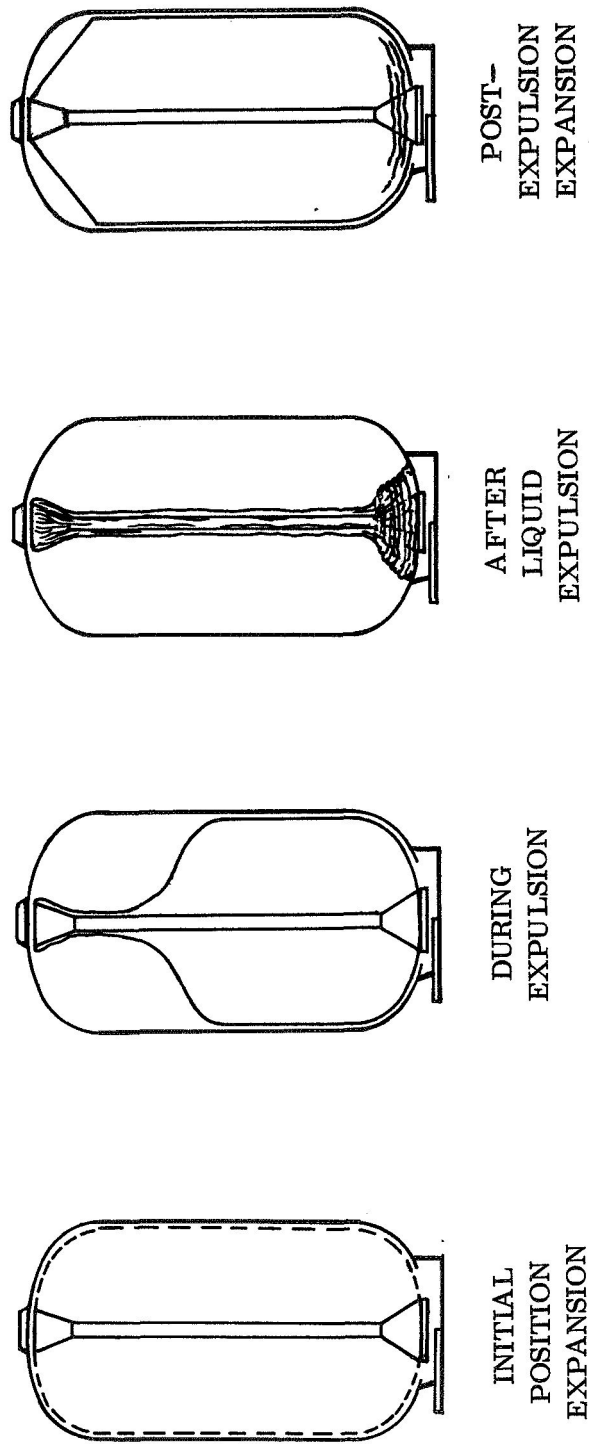
FIGURE 1. SEQUENCE OF TENSION DEVELOPMENT IN BLADDER

It has been determined by observation of previous twist tests in plexiglass tanks that twist forces buckle the hemispheres of the bladder and produce a pattern of folds which become tighter as the bladder is pressurized. Since the folds take up bladder material, the hemispherical bladder sections are initially reduced in volume. This creates a gap between the bladder and tank wall which is bridged by deformation of the bladder material

when internal pressure is applied. The folds are in diagonal tension and the bladder material between the folds is subjected to biaxial tension stresses and is thereby strained to increase the bladder volume to comply with the internal volume of the shell. After subsequent expulsion and fill operations, new folds develop, depending upon twist angle, and sequences of tight creasing and biaxial tension tend to occur in many parts of the bladder hemispherical surfaces. This sequence of loads is damaging.

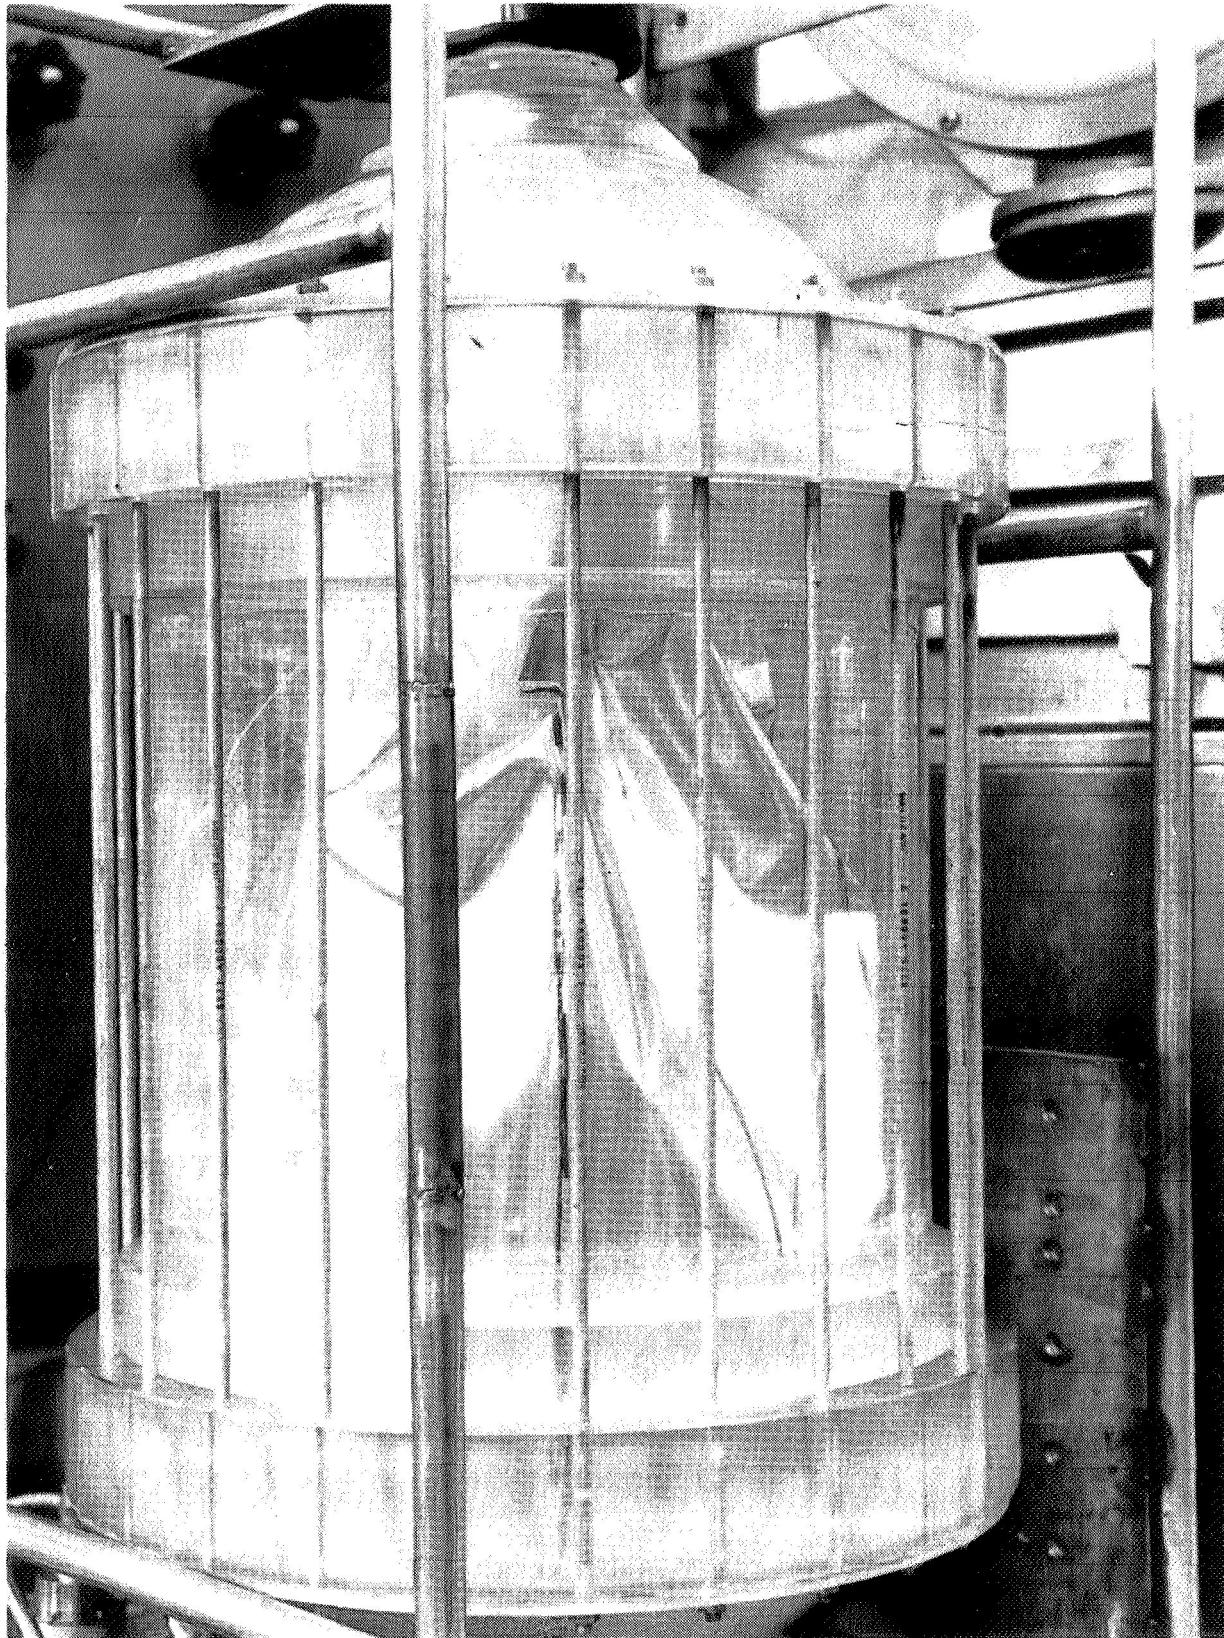
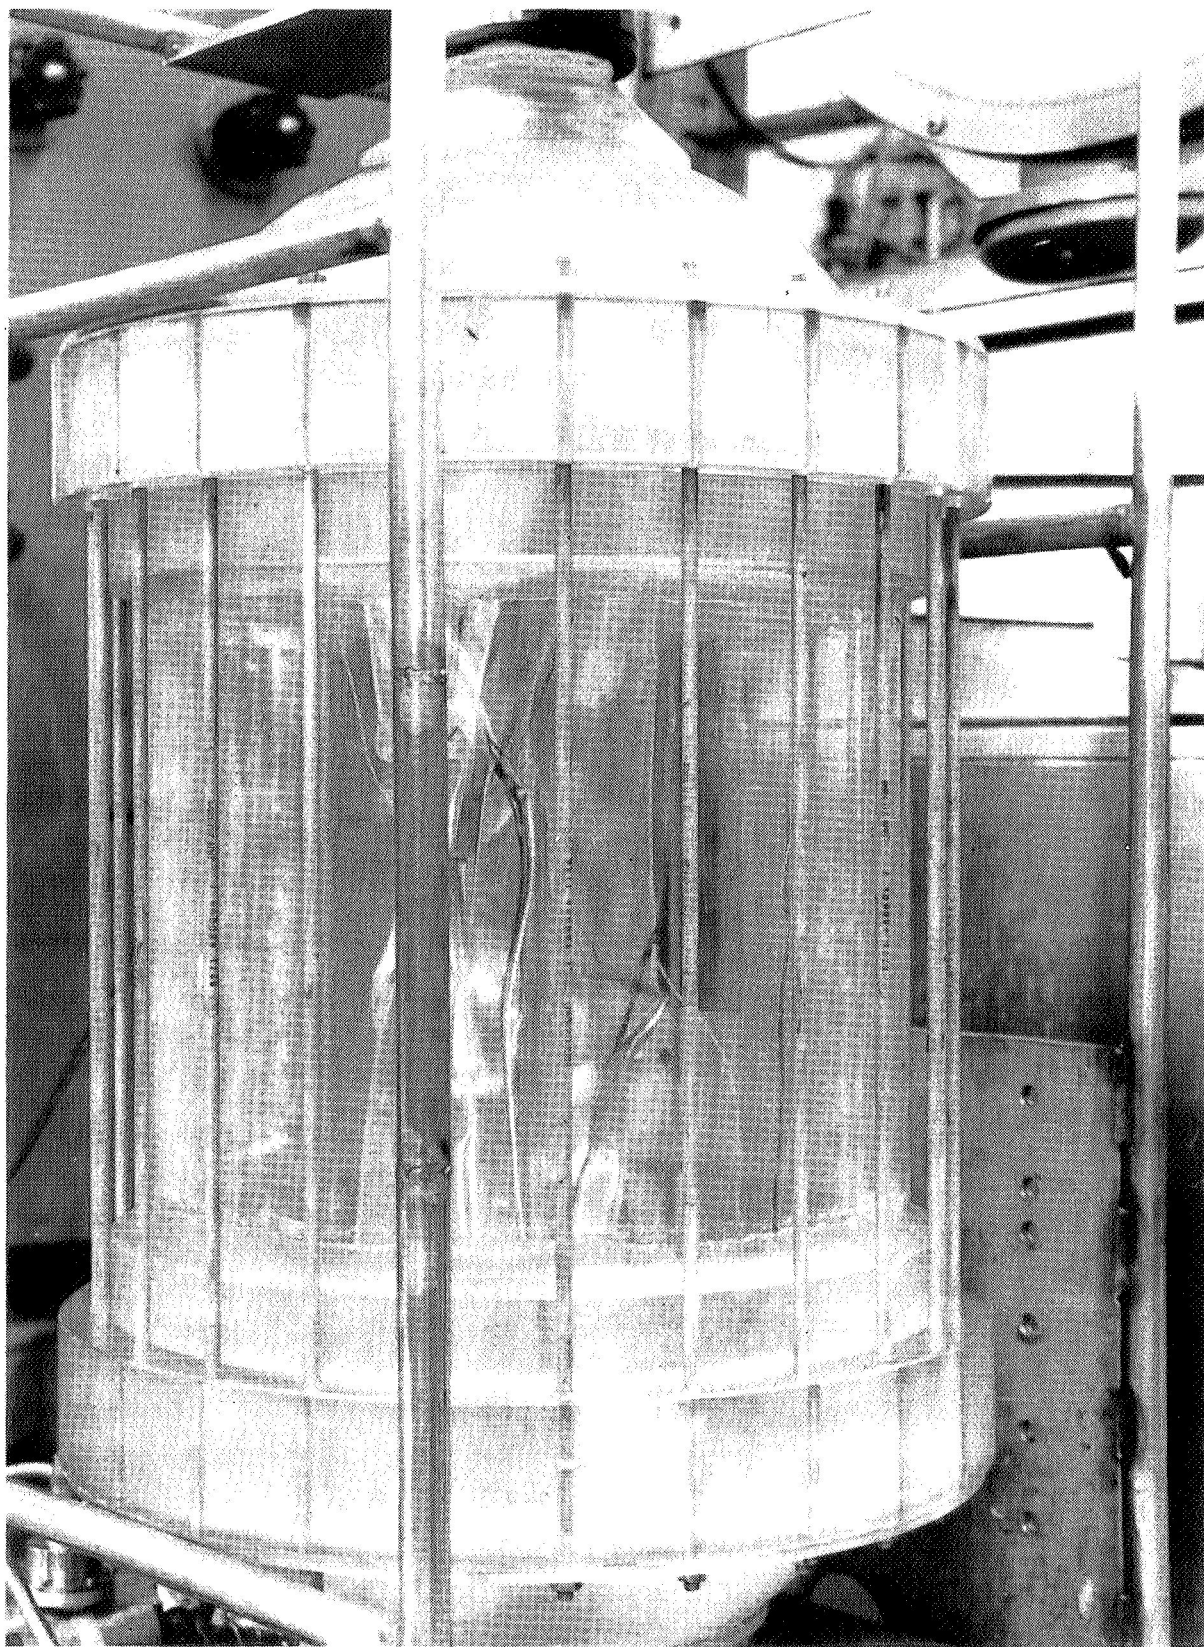
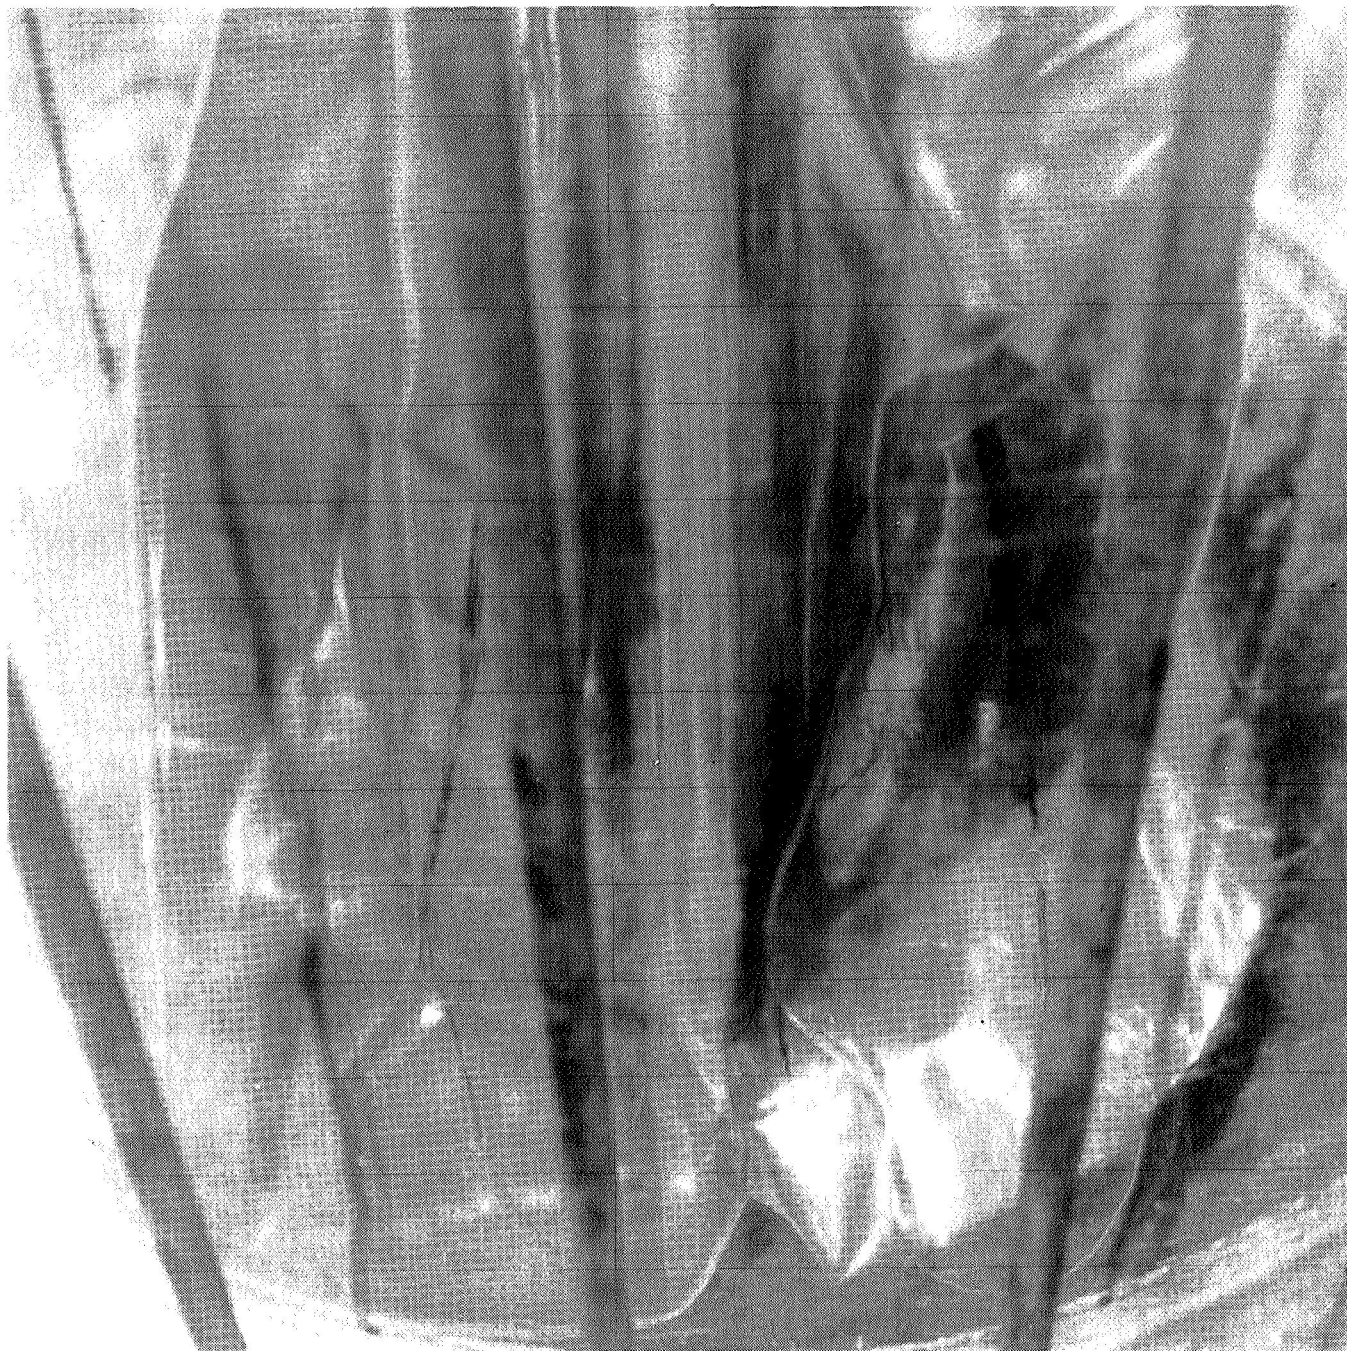
As expected, the bladder repositioned itself completely within the tank when re-expanded after each vertical expulsion with no visible evidence of strain. The cylindrical section of the bladder did not touch the tank wall until complete vertical positioning had occurred. Figure 8 shows the bladder half-way through the first expulsion and Figures 9 and 10 show the bladder appearance after completion of expulsion. As shown in Table 1 and Figure 11, expulsion efficiencies exceeded 99% at a tank assembly ΔP of 6 psi.

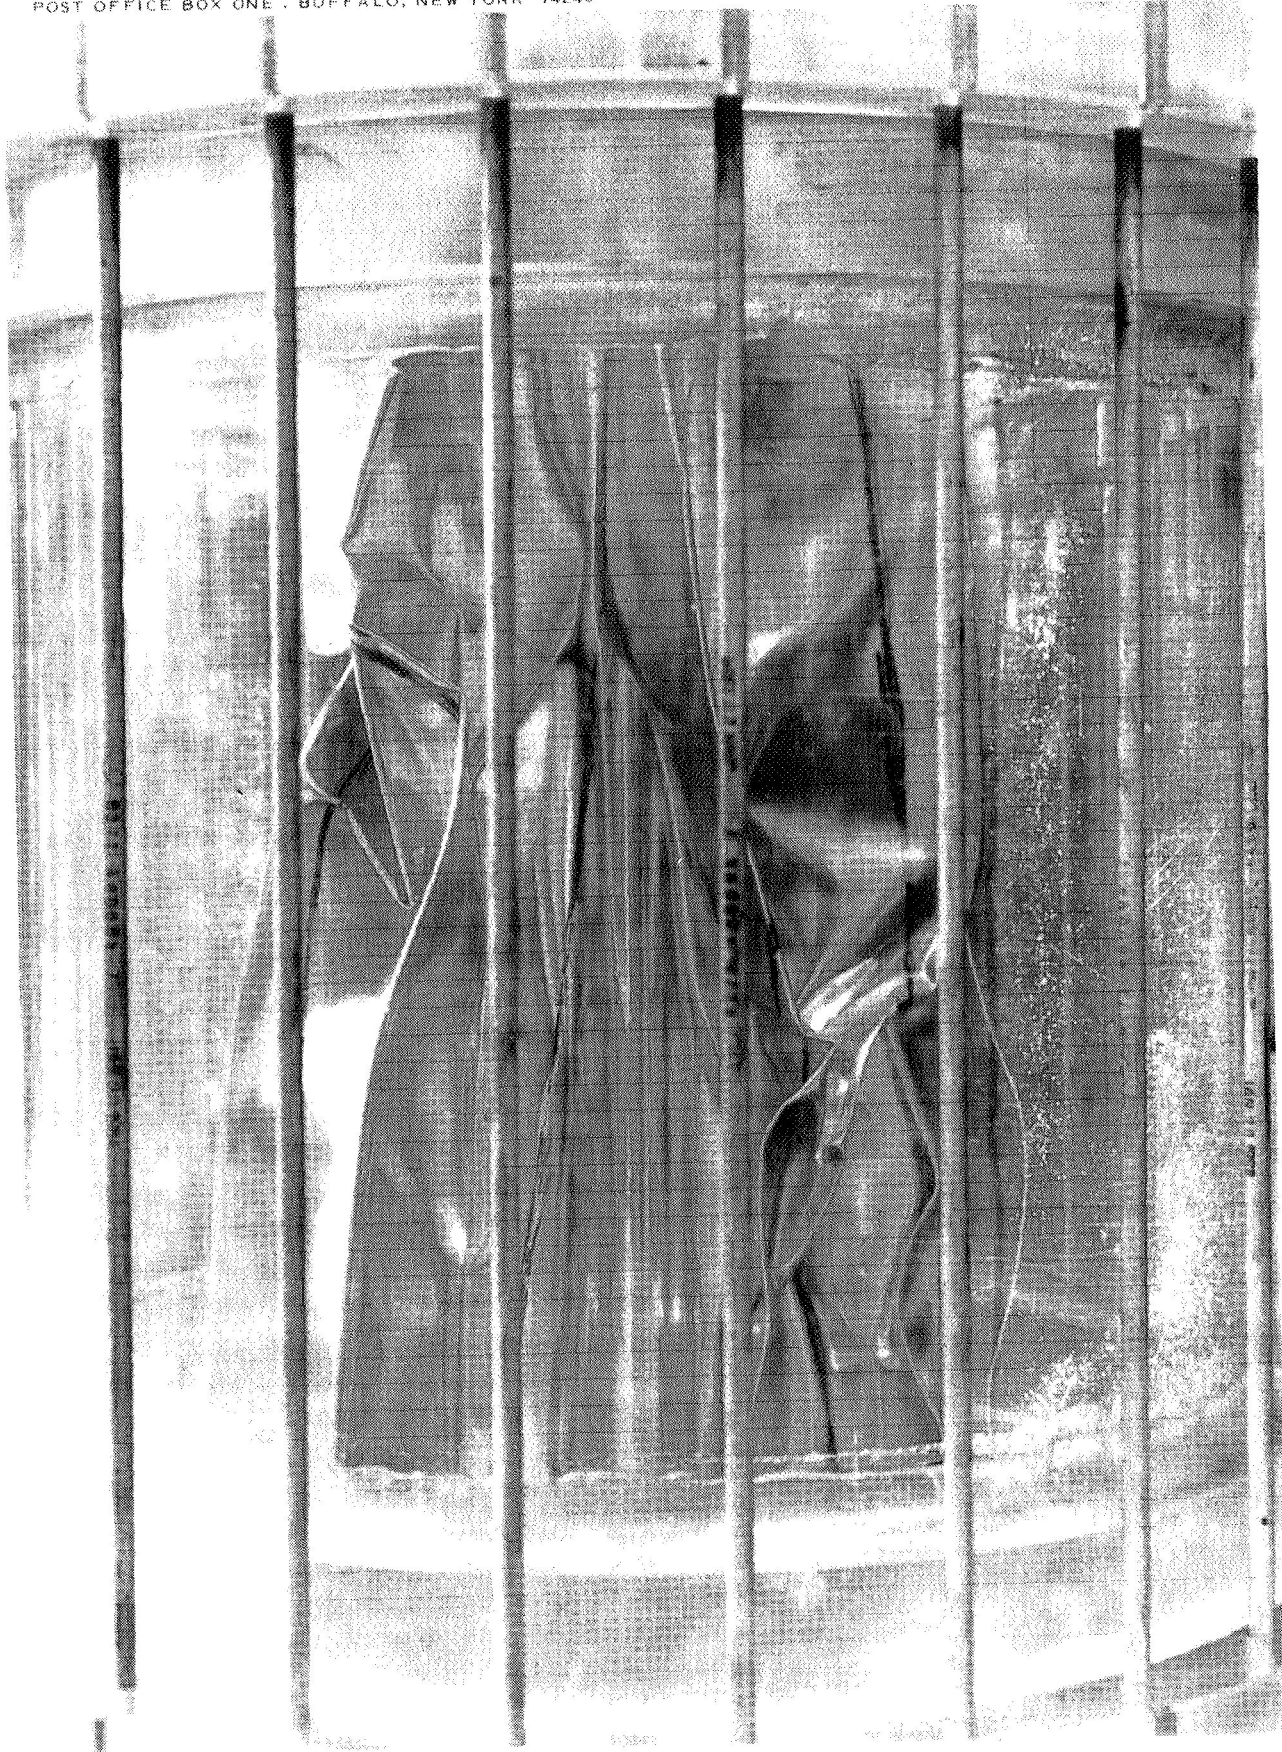
FIGURE 13. TEFLON/FOIL LAMINATE BLADDER AFTER HORIZONTAL EXPULSION - TOP VIEW

As in the case of the vertical tests, expulsion efficiencies in the horizontal attitude exceeded 99% at a tank assembly ΔP of 6 psi as shown in Table 1 and Figure 12. The first horizontal expulsion (No. 5) was not instrumented sufficiently to obtain an efficiency curve. Figures 13 and 14 are top and end views of the plexiglass tank after completion of the first horizontal expulsion.

Re-expansion of the bladder in the horizontal position after the first expulsion resulted in a 15° twist of the bladder. The same twist was experienced after each of the remaining three horizontal expulsions. In each case, the twist was removed by turning the tank to the vertical position, partially collapsing the bladder and re-expanding in the vertical position.

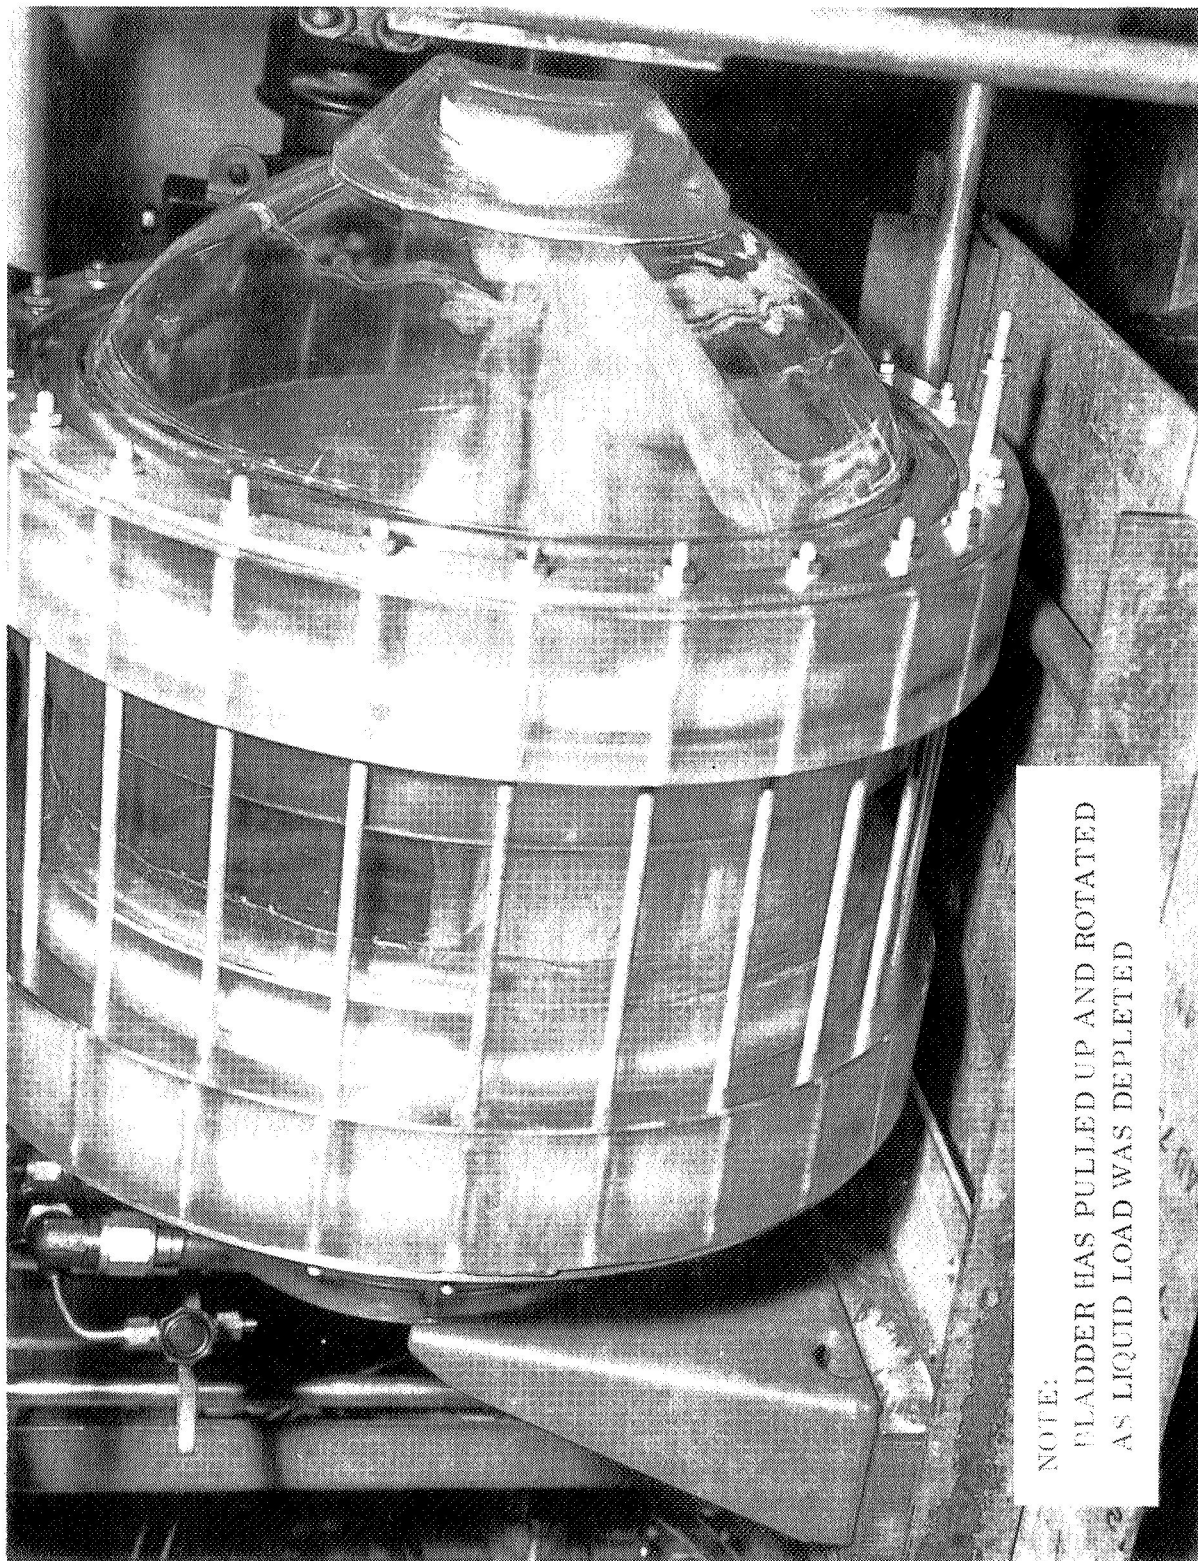
FIGURE 15. POST-EXPULSION BLADDER CONDITION IN HORIZONTAL CNO TANK

Since the Command Module RCS tanks are mounted horizontally, the bladders are susceptible to twisting during fill operations. Bladder twist is a random occurrence which depends upon folding patterns developed in the bladder during expulsion and/or subsequent evacuations as shown in Figure 15. Figure 16 is a sketch showing bladder folding patterns after expulsion and evacuation and indicates the downward rotation of a point on a fold due to propellant weight during filling. As fold A rotates and expands, it reaches the tank wall and a twist angle θ is established. At complete fill pressurization, the bladder membrane develops torsional restoring moments which are opposed by the friction between the bladder and the tank wall. In Apollo-type tanks, the friction forces are generally large enough to prevent reduction of the angle of rotation by bladder slippage and the result is incomplete repositioning of the bladder within the shell. The Apollo Command Module shell and bladder geometries are such that a bladder twist angle of 20° can be experienced without bladder damage; however in some cases bladder twist angles as great as 80° have been observed after a few expulsion cycles in Command Module oxidizer tanks. Figure 17 shows examples of twist damage on a Command Module oxidizer tank after repetitive expulsion cycle testing with propellant.

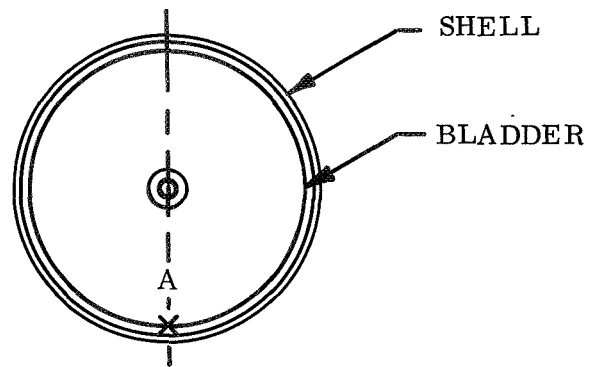
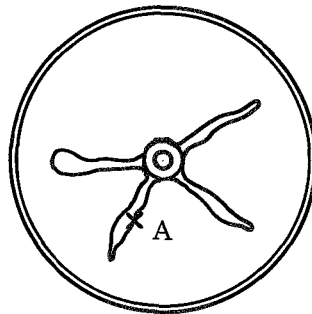
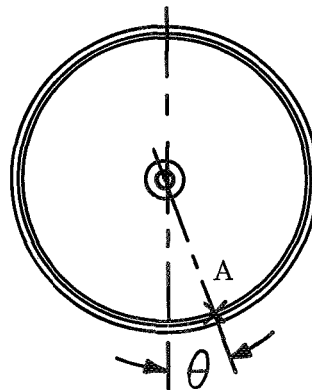
FIGURE 16. SKETCH SHOWING TYPICAL HORIZONTAL
FOLDING PATTERN AND TWIST

The twist problem associated with Command Module bladders is limited to cylindrical tanks mounted in a horizontal attitude. The bladder folds tend to twist toward the bottom of the tank when the bladder is collapsed and during subsequent filling operations the weight of the liquid may trap these folds in the bottom of the tank, thus reducing the available bladder volume. If the twist angle is large enough, severe biaxial strains develop in the bladder ends upon complete filling of the tank.

Several design approaches were studied and evaluated. These included variation of the diffuser cone flow pattern and ΔP by varying the number, size, and pattern of the holes in order to control the orientation of the bladder extremities. The objective of these modifications (as listed in Table 2) was to minimize bladder twist at the end of an expulsion and, if possible, prevent the bottom of the bladder from lifting at the end of an expulsion. If this could be accomplished, position A on the bladder as shown in Figure 16 would not change and the twist angle would remain zero.

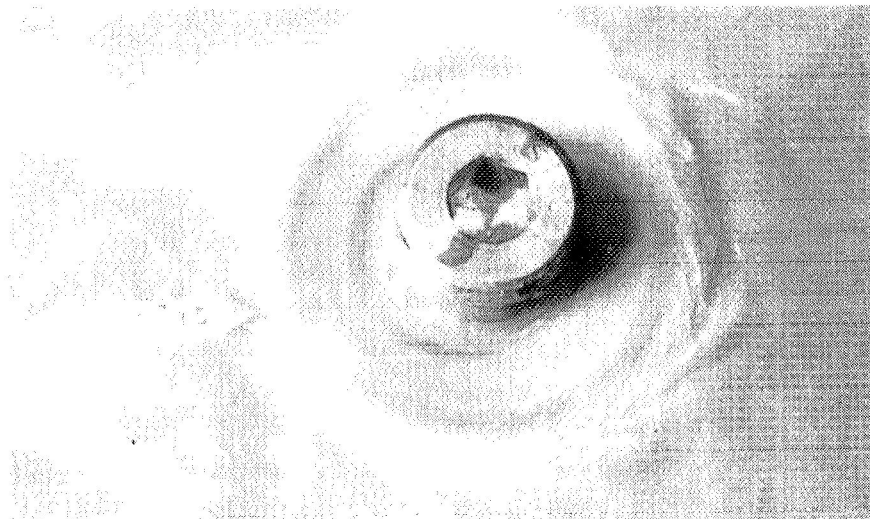
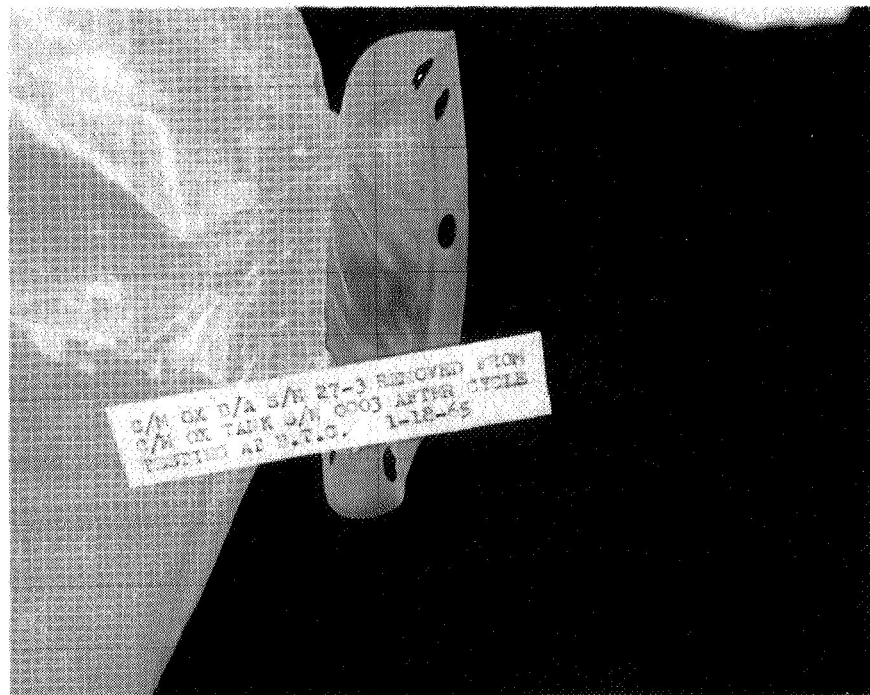
FIGURE 17. EXAMPLES OF TWIST DAMAGE ACCUMULATED DURING REPETITIVE EXPULSION CYCLING IN HORIZONTAL ATTITUDE

It should be noted that testing experience on Command Module tanks has shown that twist severity is progressive and subsequent bladder damage is cumulative with successive expulsion cycles. Thus, while twist can be severe enough to result in

S/N OK S/A 27-3 REMOVED FROM
S/N OK TANK S/N 0003 AFTER CYCLE
TESTING AT D.T.C. 1-18-65

It is recommended that, in designing vehicular or system installations, provision should be made for mounting tanks so that loading and servicing may be accomplished with the tank assembly in the vertical attitude. Tank assemblies, such as the Command Module tanks, once loaded, will perform satisfactorily in the presence of radial acceleration forces; however repetitive expulsion and evacuation for loading under these conditions can result in bladder damage and potential failure.

Dimensional analysis has shown that the current Command Module tanks would not experience bladder damage due to twist if the tanks were loaded to not more than 90% of total volume. Since these tanks are vacuum-loaded, it should be feasible to replace the existing practice of loading full and then draining ullage with a practice of loading to ullage level only. If present Apollo experience should indicate that 10% ullage is acceptable in these tanks, then an expulsion capability of 20 cycles could be reliably demonstrated.
